TEST REPORT

Report No. : HD90002A/2015

Product Description: Inner Clamp for GCC door rail

Test Requested: Pulling test

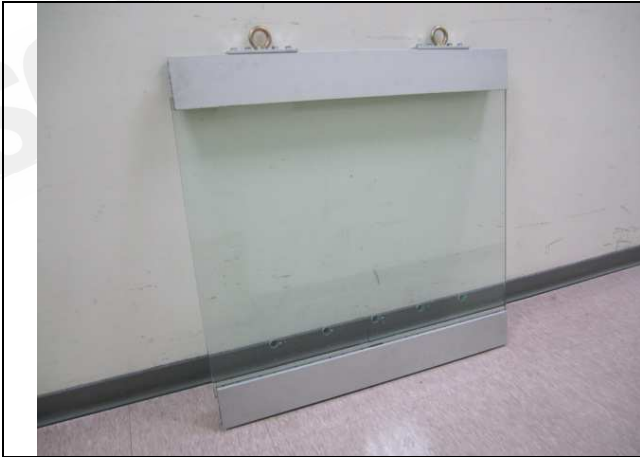
Photo A : Appearance of the sample

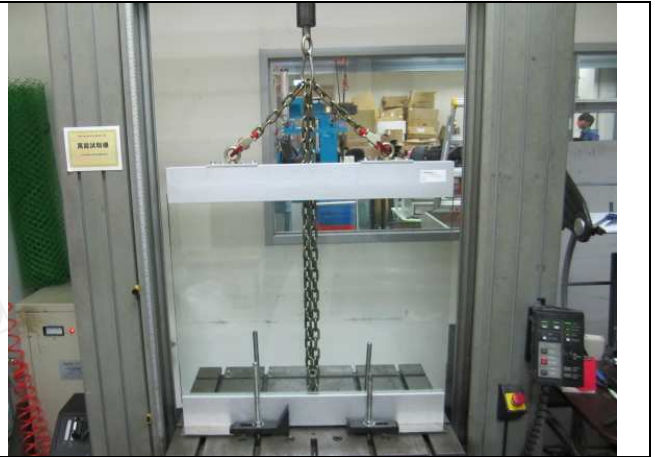
Photo B : Test setup

1. Secure the sample on the testing machine. (See photo B)
2. Apply a vertical increasing force to the sample until it is come off.
3. Record any findings and maximum pulling force.
4. Testing Machine: INSTRON 5581, Rate: 10 mm/min.
5. Testing glass width: 850 mm, Inner Clamp length: 400 mm (2 pcs/set).
